# MILLPWR<sup>G2</sup> SOFTWARE UPDATE

February 3, 2017  
MILLPWR<sup>G2</sup> 2 & 3 Axis  
Release of Version R5SP1

**For Use with Consoles (ID#1113777-NN) ONLY**

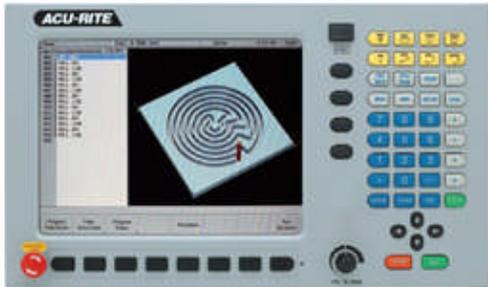
Console ID # 745604-NN

- These consoles **cannot be upgraded to R5** and will continue to receive service packs under the R4 release. Please do not attempt to install release 5 (R5) onto these consoles.

- System drive restructuring on this original design consoles will cause the console to become un-operational and require in house service to correct the issue. **Do not restructure the drive on these consoles.**

- **Not all software enhancements will be included in future R4 releases** . We will continue to support console ID# 745604-NN with service packs through the R4 released software that will mainly include minor enhancements or fixes.

- USB Recovery Drive Kit 1201909-01 includes a compatible USB Recovery Drive ID# 680480-03 for original G2 consoles (ID#745604-NN) and should be ordered when replacing a recovery drive for these consoles. This drive does not include the restructuring option, so the unit cannot be restructured accidentally.

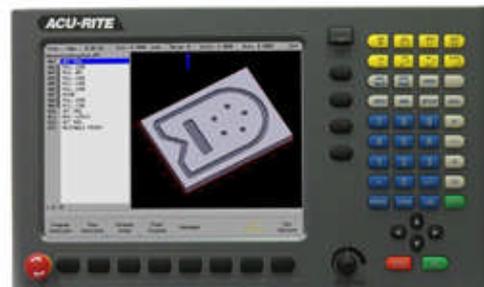
Console ID # 1113777-NN

- **R5 cannot be installed unless you have R4SP4 installed first** . If you have previous version of software such as R1, R2, or R3 SPx (release 1, release 2, or release 3 with any service pack) download and install R4 SP4 prior to updating to R5.

- Due to the enhanced features of release 5, it has become necessary to restructure the console's hard drive. USB Recovery Drive ID# 680480-04 is now included in Recovery Drive Kit ID# 1127022-01 which supports all G2 consoles and all software versions to date or planned for the near future. This new recovery drive includes an option for resizing the control's hard drive partitions. This must only be performed on current consoles (ID#1113777-NN) that are running software release 4 service pack 4 (R4 SP4). Please insure the console is updated to this release prior to restructuring the drive and installing release 5 (R5). Hard drive restructuring is required on these consoles prior to the upgrade to release 5 (R5).
